TECHNICAL REPORT REMR-CO-3

CASE HISTORIES OF CORPS BREAKWATER
AND JETTY STRUCTURES

Report 5

NORTH ATLANTIC DIVISION

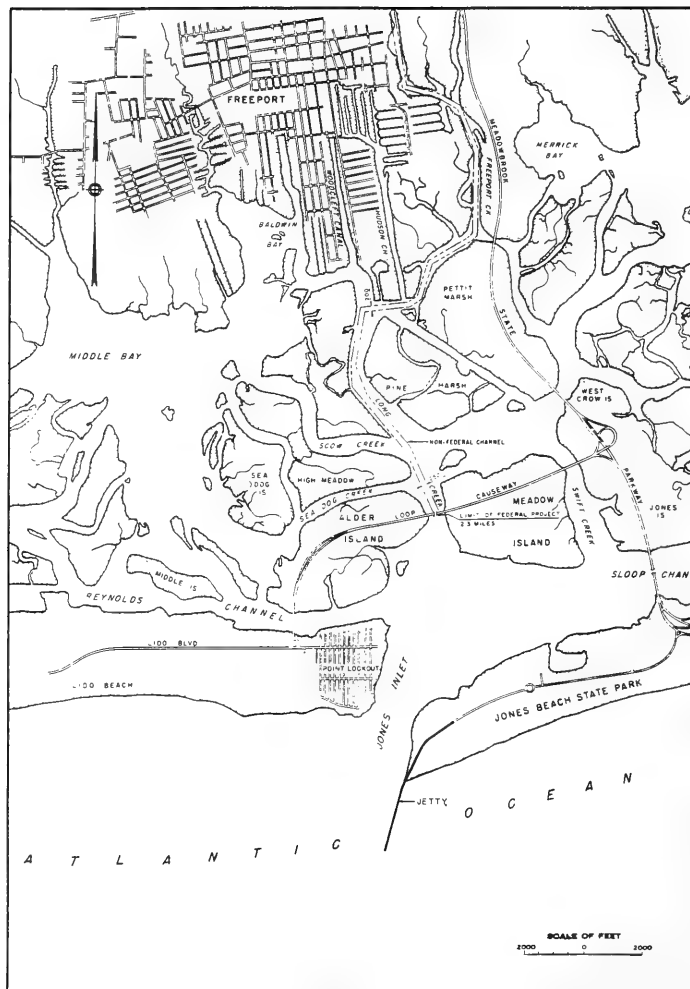
Figure 22. Jones Inlet, New York

1962	The Middle Atlantic coastal storm of 6-8 March 1962 damaged the jetty. The outer 200 ft was raveled and broken down to the high water level. A second layer of capstone was added to the outer 120 ft to restore the original design. The adjacent 1,080 ft shoreward was repaired by replacing armor stone and by adding stone. Armor stone was replaced on the adjacent 900 ft shoreward.
1985	The jetty had nearly reached impoundment. Sand was bypassing the jetty, mostly through large voids at the jetty-shoreline intersection. The apron had settled approximately 7.0 ft at the seaward end due to sand loss through voids in the apron.
1986	No further repair or maintenance information has been found.

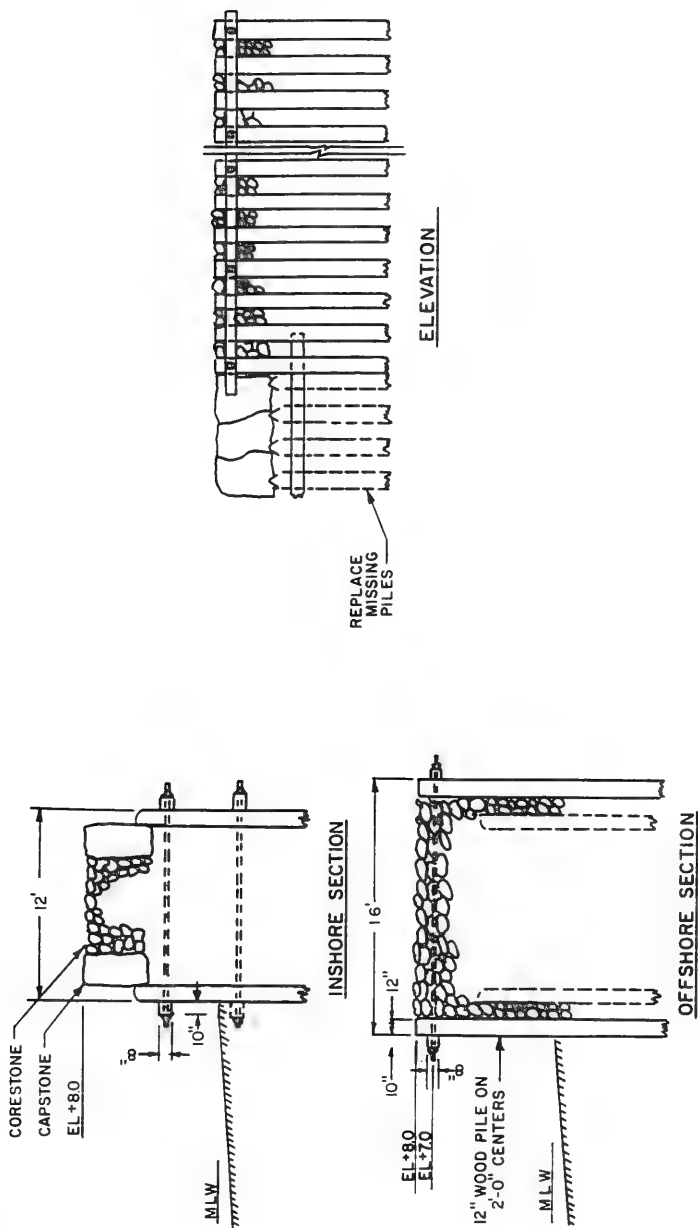
Figure 29. Rehabilitation of Mantua Creek jetties, 1963

<u>Date(s)</u>	<u>Construction and Rehabilitation History</u>
1907	Two jetties were constructed to provide channel protection. Lengths were 754 ft and 580 ft east and west, respectively. The jetties were constructed of stone-filled timber cribs, with mat brush placed to support the stone (Figure 28). Top width and elevation were 12.0 ft and +8.0 ft mlw, respectively, for each jetty.
1912-1913	The east jetty was extended to 1,577 ft, and the west jetty was extended to 1,456 ft (Figure 28).
1918	Repairs were made by the addition of stone.
1962	An investigation of the jetties revealed the jetties had settled an average of 2.0 ft. Approximately 100 ft of the offshore end of the east jetty had deteriorated, with most of the pilings gone, and stone had fallen out to below the waterline. Most of the walings had deteriorated and were missing. Piles were missing at intermediate locations along the jetties, but there was no significant loss of stone at those locations. Piles that remained were in good condition.

1963	The jetties were rehabilitated at a cost of \$136,895. A new row of piles was placed over approximately 100 ft at the offshore ends. Piles were placed 7.5 ft on either side of the center line of the jetties. Corestone was dumped between the piles to an elevation of +8.0 ft mlw (Figure 29). Missing piles were replaced, and new wales were provided along the remainder of the jetties. One row of capstone was placed on the inner sides of both cribs on top of the existing stone to +8.0 ft mlw. Core stone was filled between the capstones in the center of the jetties to +8.0 ft mlw (Figure 29). Crown width was 16.0 ft at the offshore ends and 12.0 ft on the remainder of the jetty. Design wave height was 4.2 ft.
1964	Repairs were made to the seaward end of the east jetty at a cost of \$4,864. The Corps was reimbursed later for this work.
1986	No further repair or maintenance information has been found.

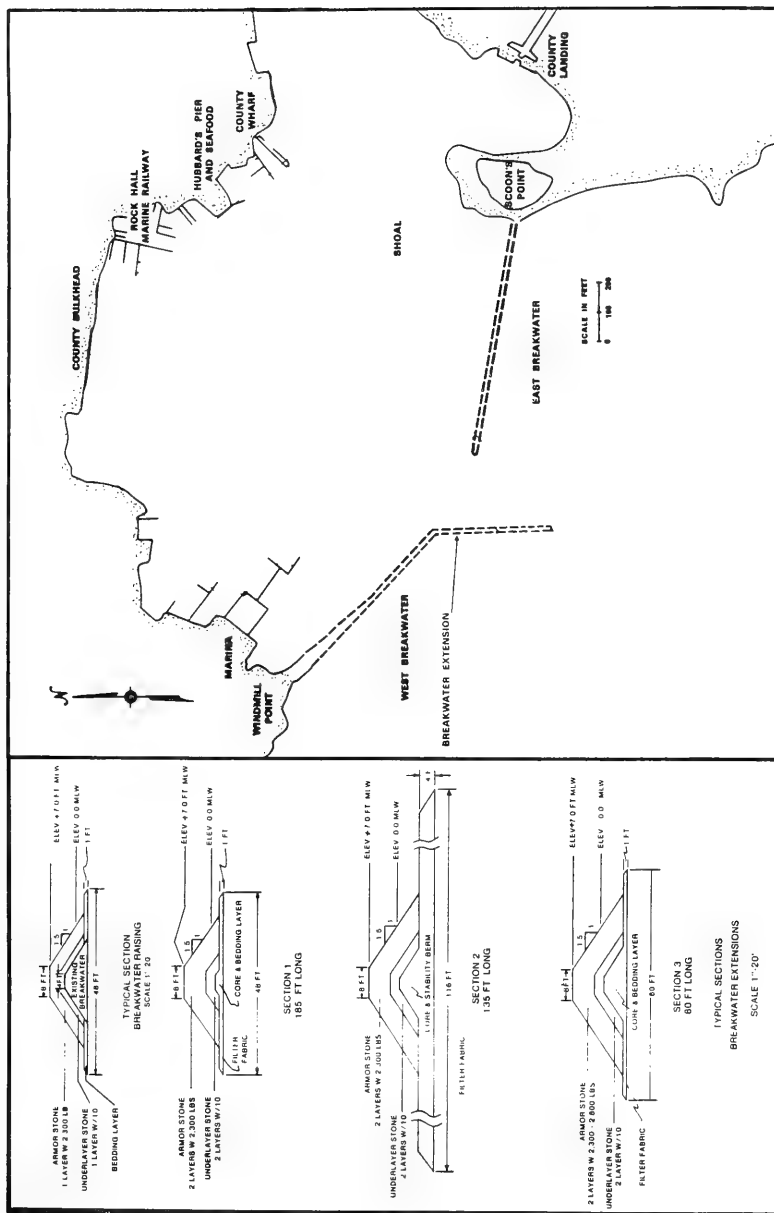
Figure 52. Plan view and cross sections of 1982 rehabilitation, Rock Hall Harbor

1982	Extensive rehabilitation was done to both breakwaters due to wave transmission and overtopping causing excessive wave heights (greater than 4.0 ft) in the inner harbor. Estimated cost of the rehabilitation was \$1,800,000 and required over 27,000 tons of stone. Crown elevation was raised to +7.0 ft mlw, crown width was widened to 8.0 ft with three capstones, and side slopes remained 1V:1.5H requiring 12,400 tons of stone. The west breakwater was extended to 1,100 ft requiring 14,800 tons of stone. Cover stone used for rehabilitation ranged from 2,300 lb at the trunk to 2,800 lb at the head. Cross sections and location of the rehabilitation are shown in Figure 52.
1986	No further repair or maintenance information has been found.
